# Evaluation Of The Silver Tarnish Problem, Launch Processing System

TEST REPORT

National Aeronautics and Space Administration  
Kennedy Space Center  
Materials Testing Branch

The Materials Testing Branch was requested to evaluate the effects of silver "tarnishing" of components of the Launch Processing System. The area of most significant concern found is the "tarnish" effects on the wire-wrap wires of the older LPS circuit boards. If maintained in the proper environment the LPS hardware could be expected to have a significantly extended operational life, despite the relatively poor quality of some hardware.

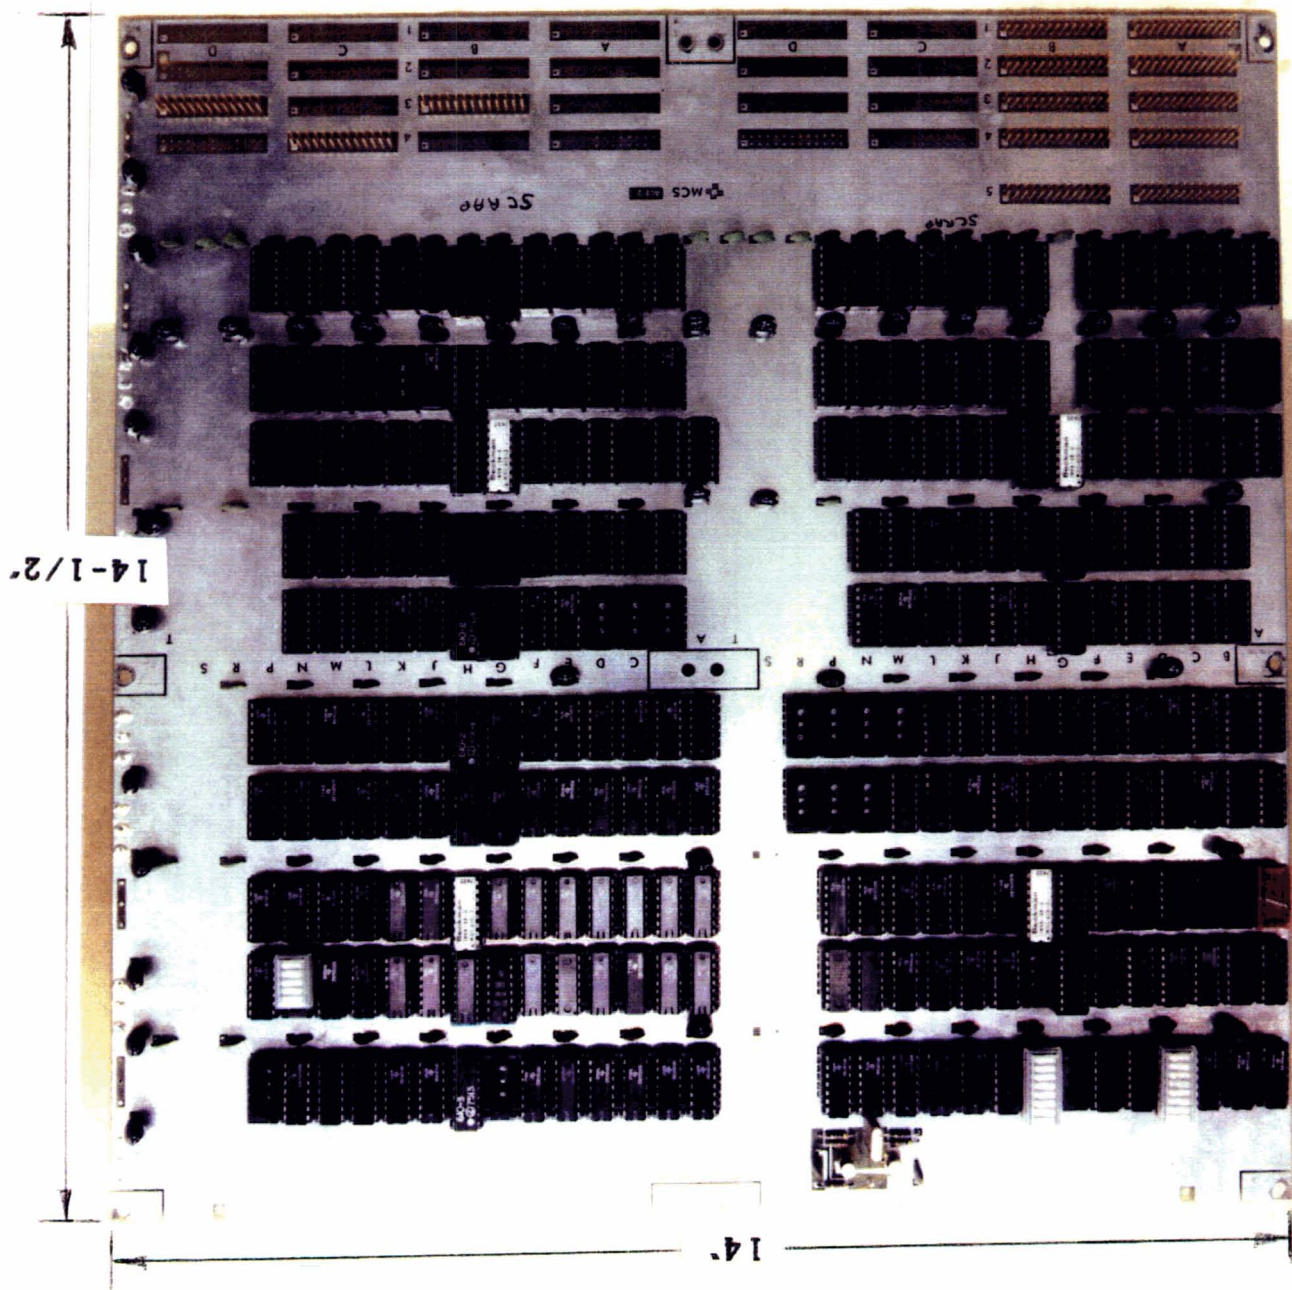
FIGURE 4-1

4.1.1 Board No. 1, Magnetic Tape Controller Board, was visually examined (see Figure 4-1 and 4-2). The board contained approximately 280 black body IC sockets with wire-wrap posts. The majority of the sockets contained IC's which carried date codes ranging from 1971 through 1975.

THE TOP (IC) SIDE OF BOARD NO. 1, MAGNETIC TAPE  
CONTROLLER, IS SHOWN.

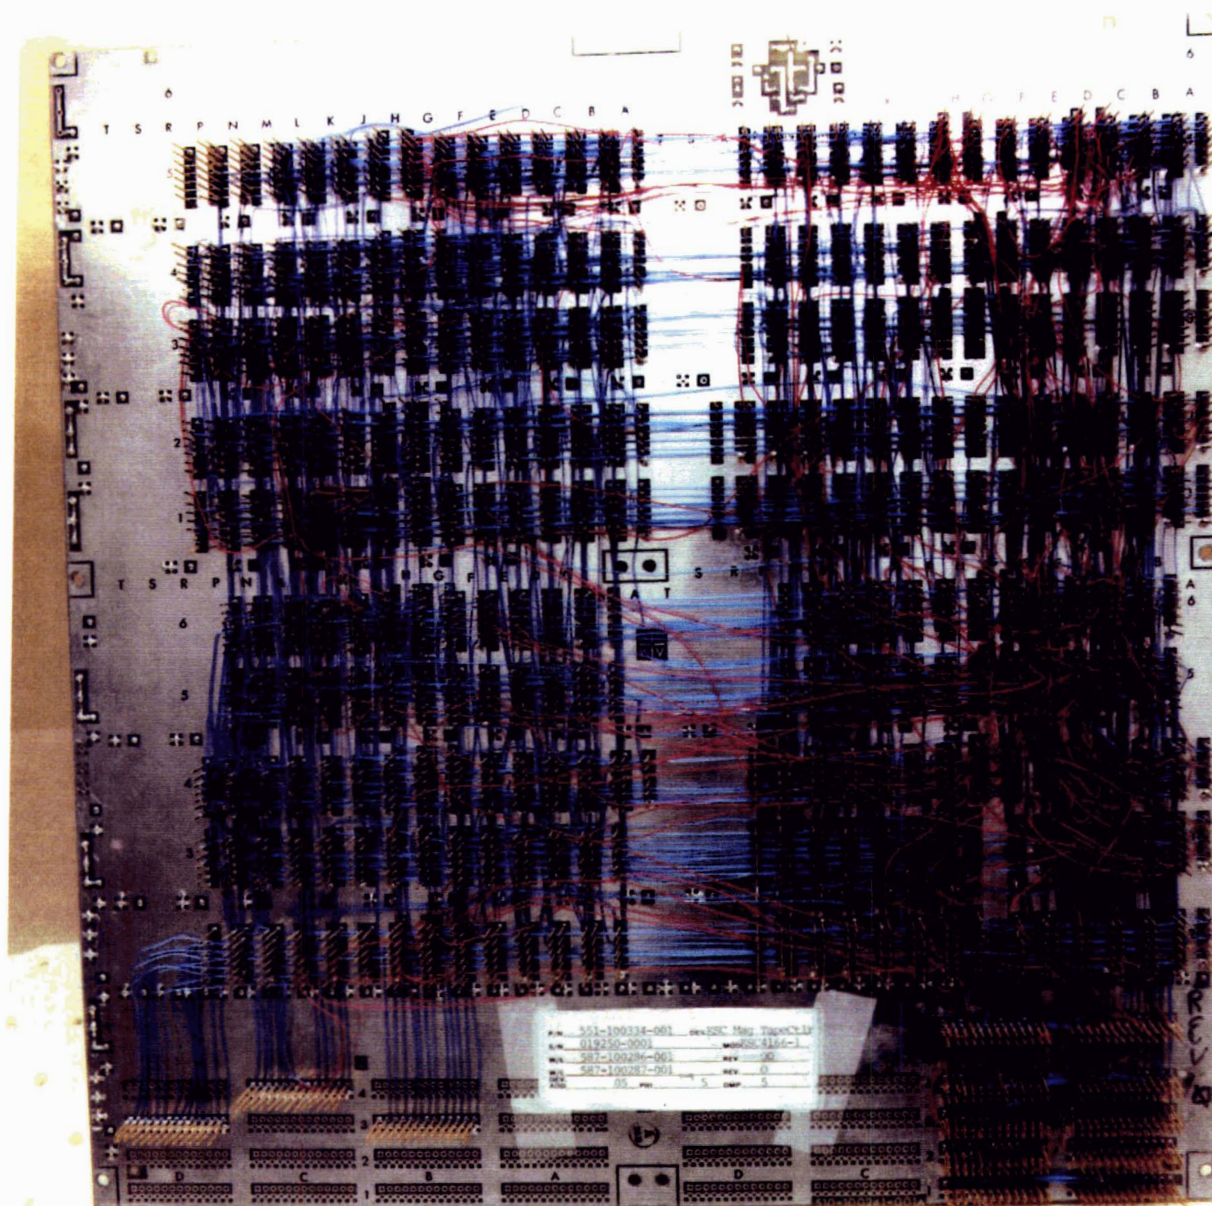
FIGURE 4-2

THE BOTTOM (WIRE-WRAP) SIDE OF BOARD NO. 1,  
MAGNETIC TAPE CONTROLLER, IS SHOWN.

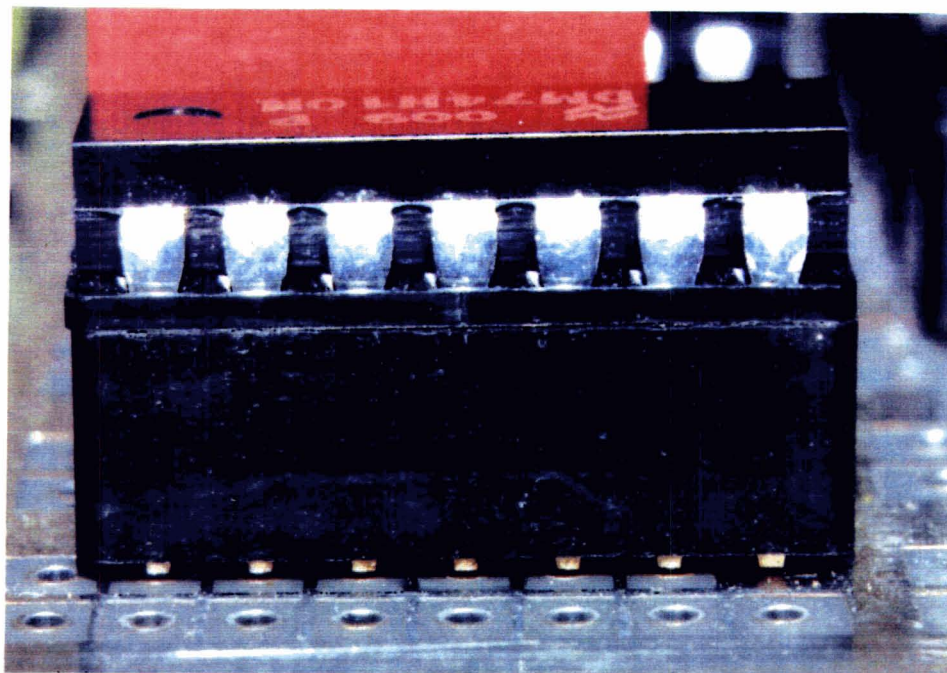
FIGURE 4-5

4.2.2 The majority of IC pins were bright and shiny (see Figure 4-5) and the wire-wrap wires were also a bright silver in color (see Figure 4-6). Many of long wire-wrap wires appeared to be hanging loose like random strands of cooked spaghetti.

AN IC WITH TYPICAL SHINY PINS ON BOARD NO. 2 IS SHOWN.

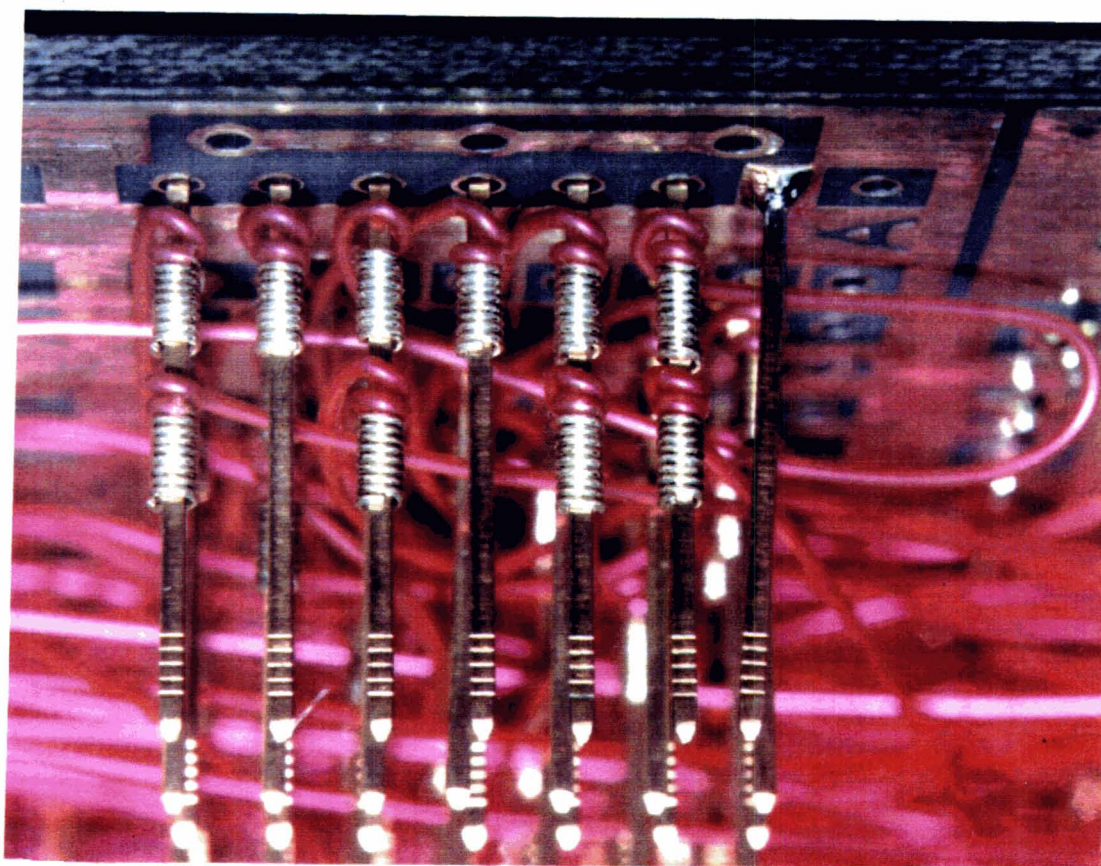
FIGURE 4-6

WIRE-WRAPS ON BOARD NO. 2 ARE SHOWN. THE EXPOSED WIRES WERE ALL BRIGHT AND SHINY SILVER IN COLOR.

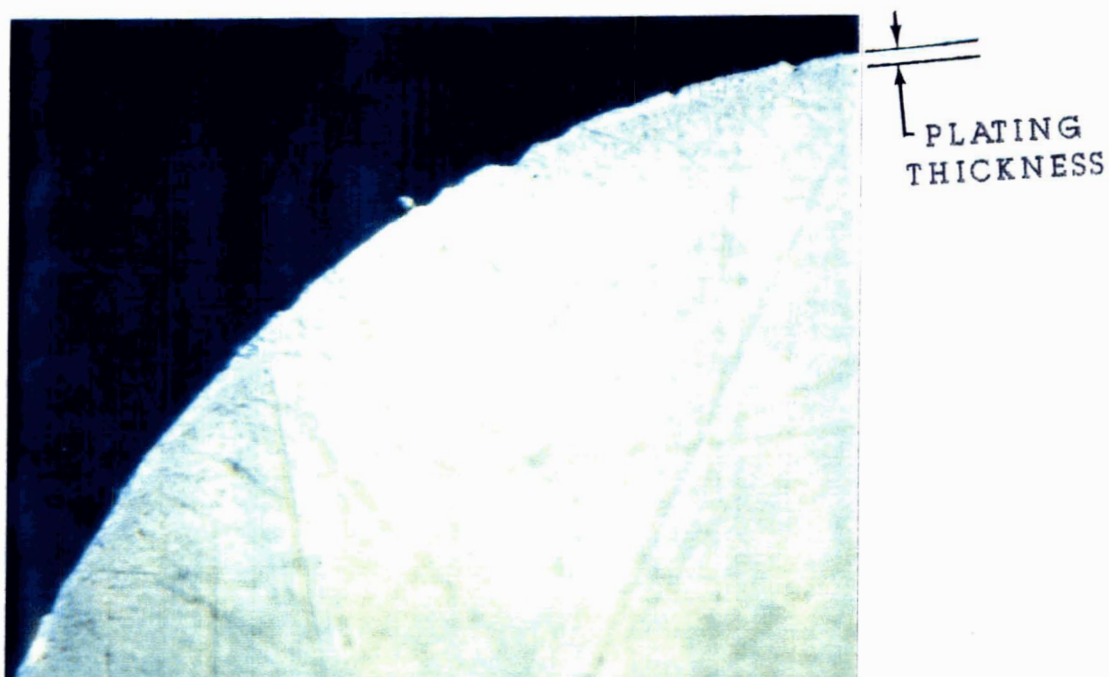
FIGURE 4-12

- 4.7.1 The silver plating was found to be approximately 40 to 60 microinches or 10,000 to 15,000 angstroms thick (see Figure 4-12).
- 4.7.2 The majority of the wire protected by the insulation in area "A" was unaffected by the  $H_2S$  environment (see Figure 4-12). One of the 7 area "A" specimens showed evidence of corrosion penetrating the protective silver plating (see Figure 4-13).
- 4.7.3 The exposed wires in area "B" showed some evidence of corrosion penetration into the Cu (see Figure 4-14).
- 4.7.4 The exposed wire close to the ends which are probably subjected to the most stress and damage during the wire-wrap process, showed the greatest evidence of corrosive attack (see Figure 4-15).

PHOTOMICROGRAPH OF A TYPICAL AREA 'A' WIRE CROSS-SECTION. THE Ag PLATING HAS BEEN SUBJECTED TO MECHANICAL DAMAGE ONLY.

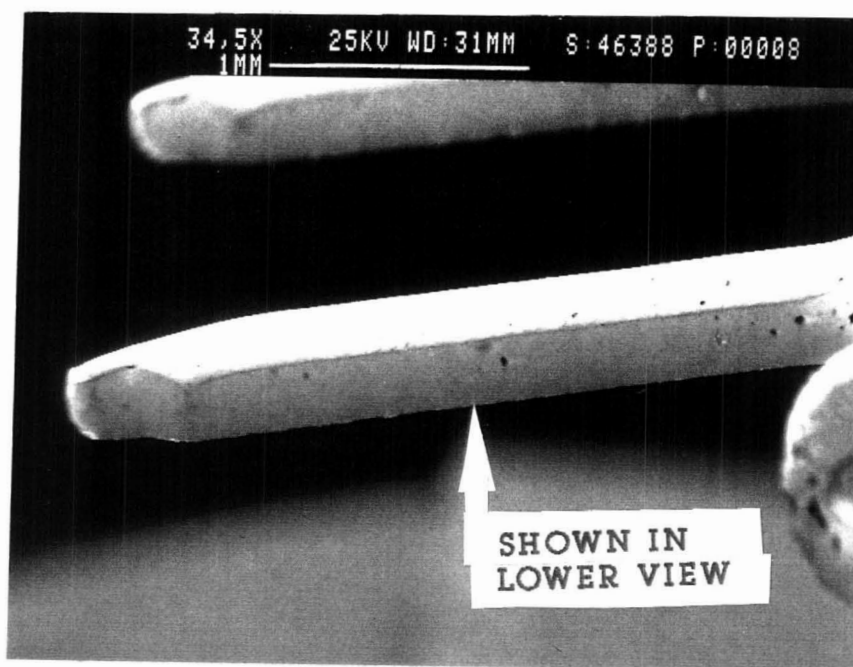
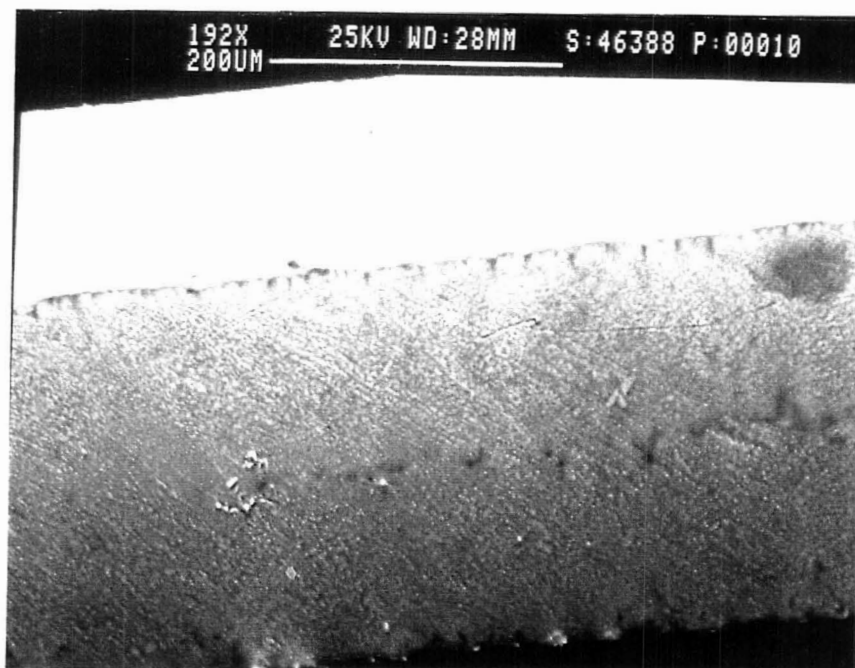
FIGURE 4-19  
SEM-PHOTOMICROGRAPHS OF A Pb-Sn PLATED PIN OF IC  
SN7404N, (8)748. THIS IC WAS UNUSED.

4.8.2 The pins of an IC which was obtained new from a commercial hobby source were examined. The IC's model number was SN7404N, with a date code of 748C. The pins were Cr-steel, with a Pb-Sn coating. The coating was found to contain a few voids or pits (see Figures 4-18 and 4-19) and the coating appeared to be relatively thicker than that on the pins of the previous IC, SN54LS170J. One of the voids was noted to have a high Si content. This IC was unused.

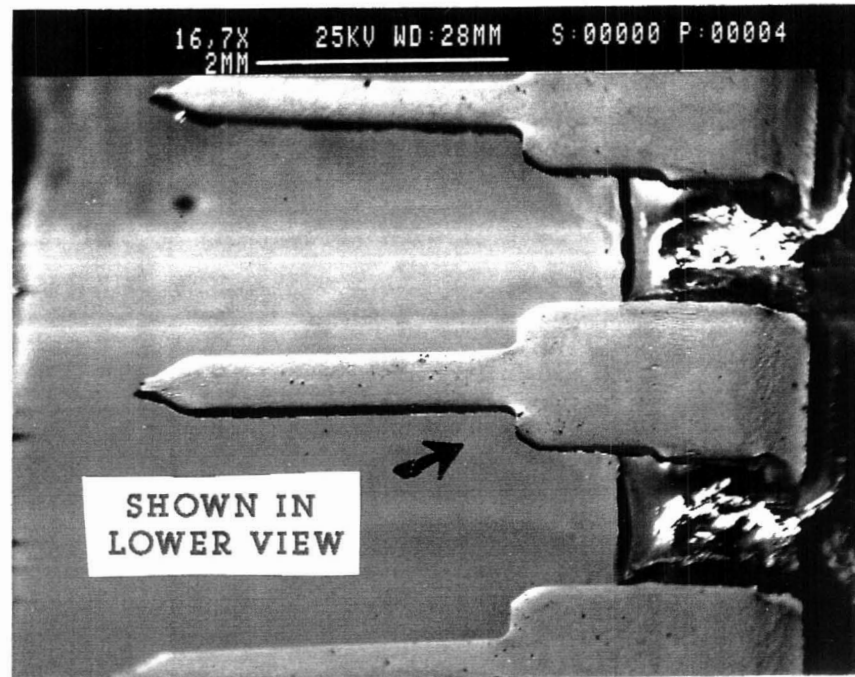
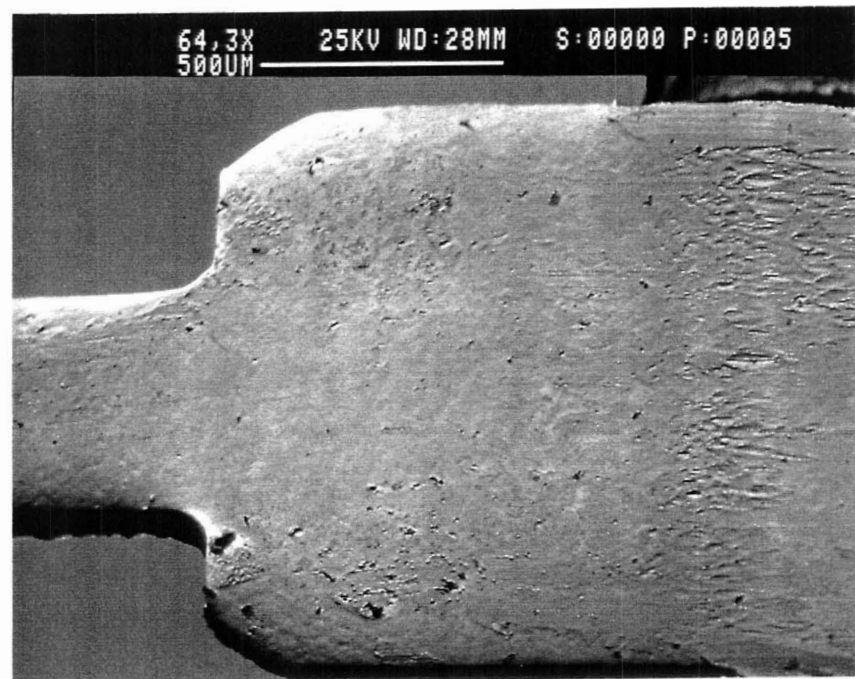
FIGURE 4-20

- 4.8.3 The pins of an IC randomly selected from Board No. 1 was examined. The IC's model number was not documented. The pins appeared to have a relatively heavy coating of Ag over the Fe-Co-Ni alloy (see Figure 4-20). On approximately half of the depth of the contact face (see Figure 4-21) the surface appears rough beneath the Ag coating. Smearing of the Ag coating due to contact with the socket is evident. The actual contact area traversed less than half of the pin thickness.

SEM-PHOTOMICROGRAPHS OF THE Ag PLATED PINS OF AN IC FROM BOARD NO. 1. THE Ag COATING APPEARS TO BE RELATIVELY HEAVY/THICK.

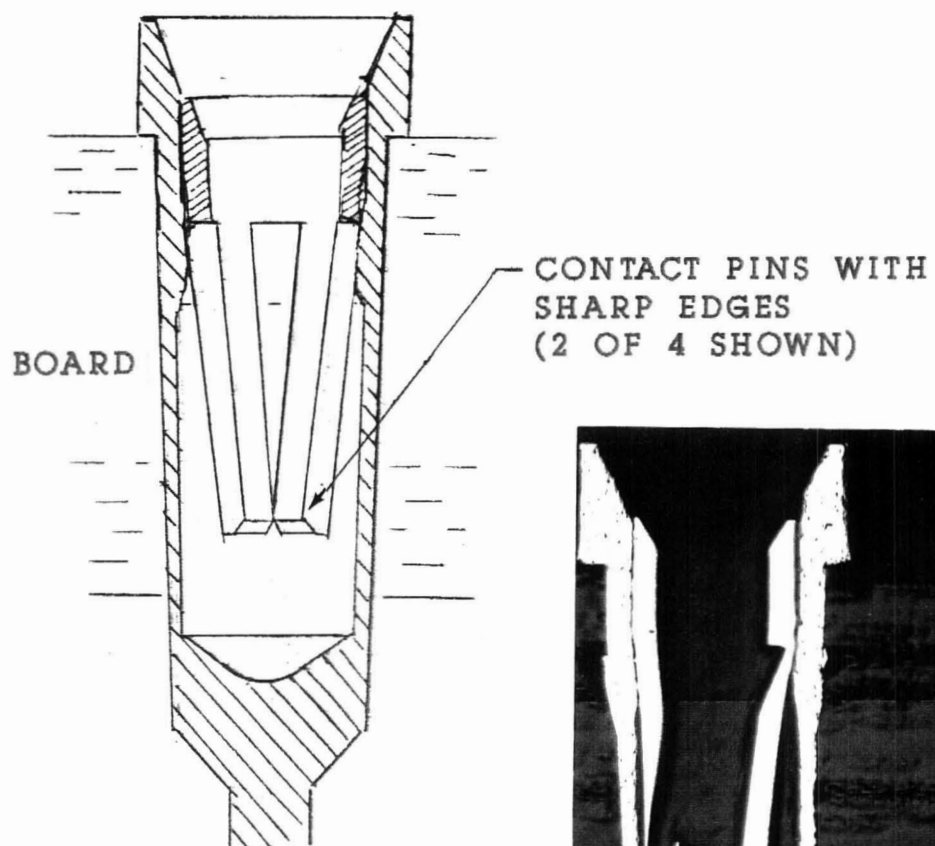
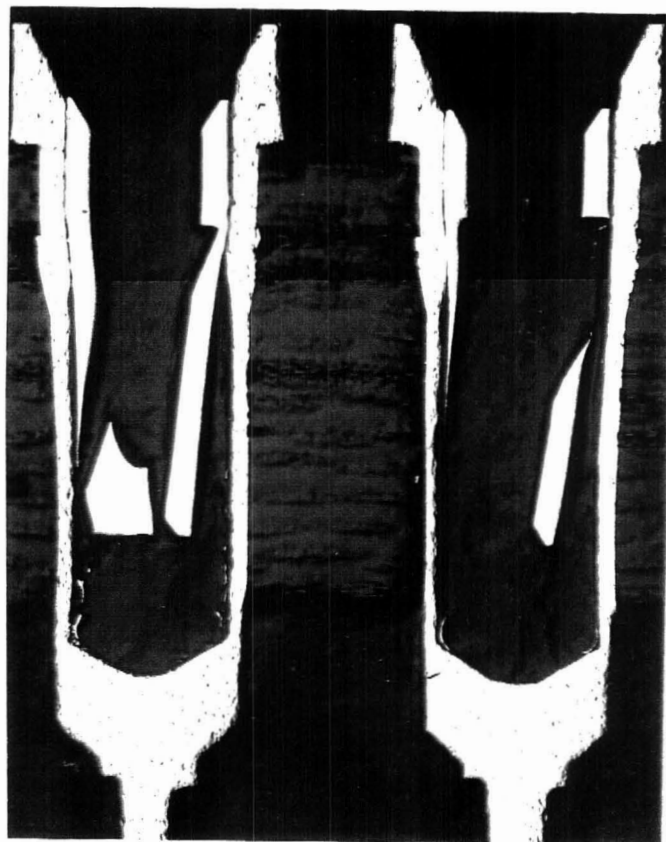
FIGURE 4-27

- 4.9.3 The Board No. 3 socket examined (see Figure 4-27) was found to be a two piece structure consisting of an outer body with an insert which had 4 contact fingers. The body was identified as a Cu-Zn alloy which was Au plated over a Ni flashing on the exterior surface. The insert was identified as primarily Cu with the Au plating on all surfaces.

PHOTOMICROGRAPH (RIGHT) SHOWS CROSS-SECTION OF A SOCKET FROM BOARD NO. 3, AND A DRAWING (LEFT).

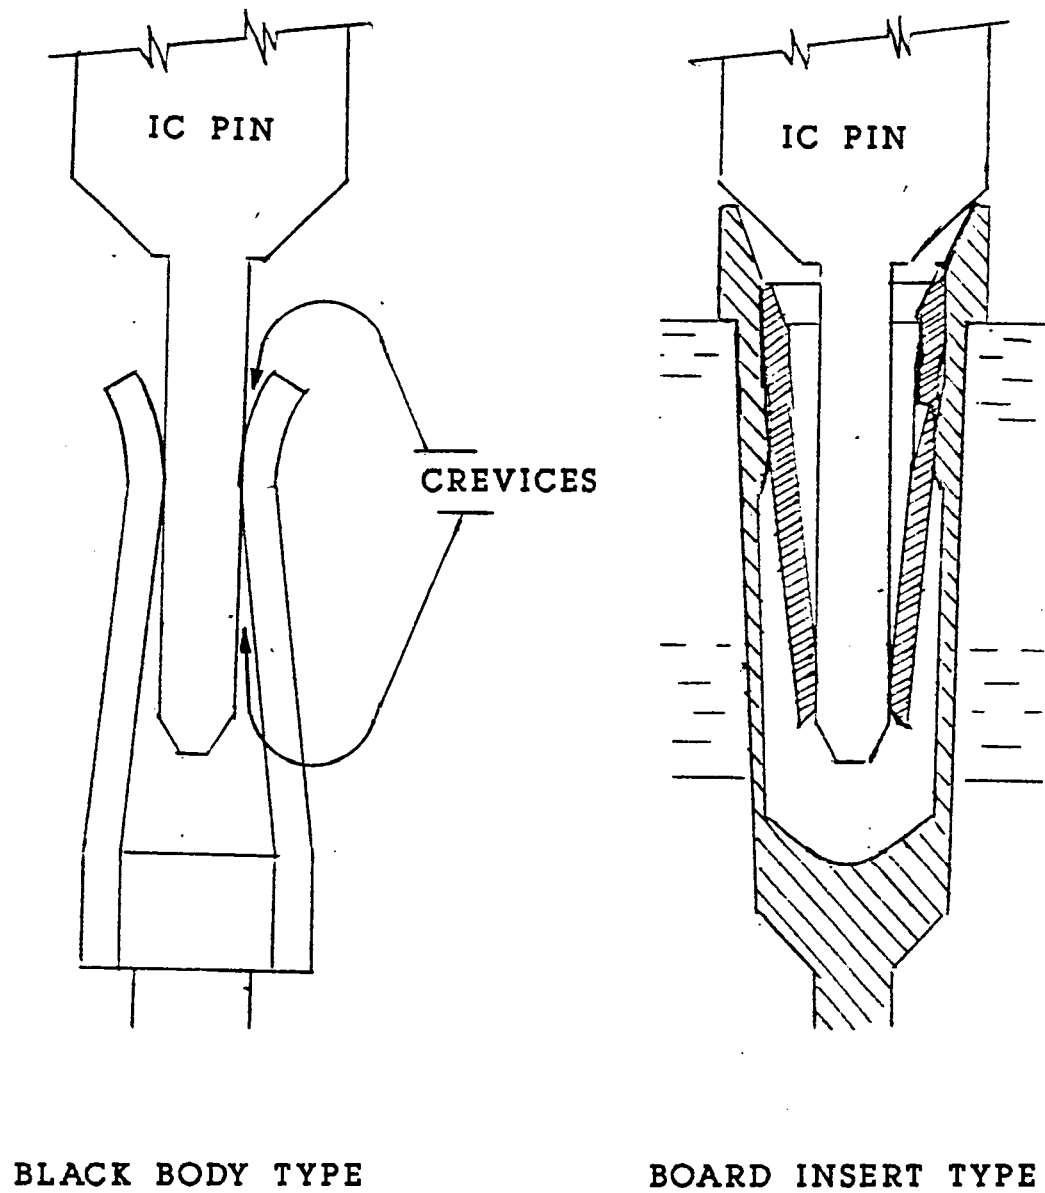
FIGURE 4-28

- 4.9.4 The black body type sockets used on Boards No. 1 and No. 2 (see Figure 4-28) provide two contacts per pin. As the pins are inserted the relatively soft Ag or Sn plating of the pin is deposited on the contacts to provide a low resistance couple between the pin and the contacts.
- 4.9.5 The type of socket used on Board No. 3 provides a minimum of two and possibly four contacts per pin (see Figure 4-28). The insert within the socket has four contact fingers to make contact with the IC pin.
- 4.9.6 The design of black body type socket to pin contact allows for a crevice corrosion situation to occur above and below the contact point. The Board No. 3 socket appears to be less susceptible to this problem due to the sharp edge contact configuration and the crevice created on only one side. Other factors such as the contact force also contribute to contact integrity.

THE PIN-SOCKET CONTACT OF THE TWO TYPES OF SOCKETS IS ILLUSTRATED.

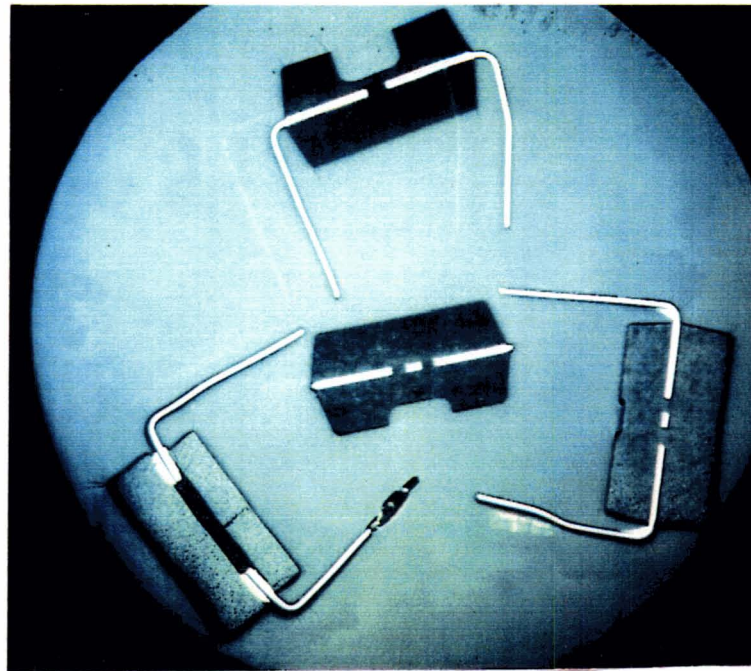
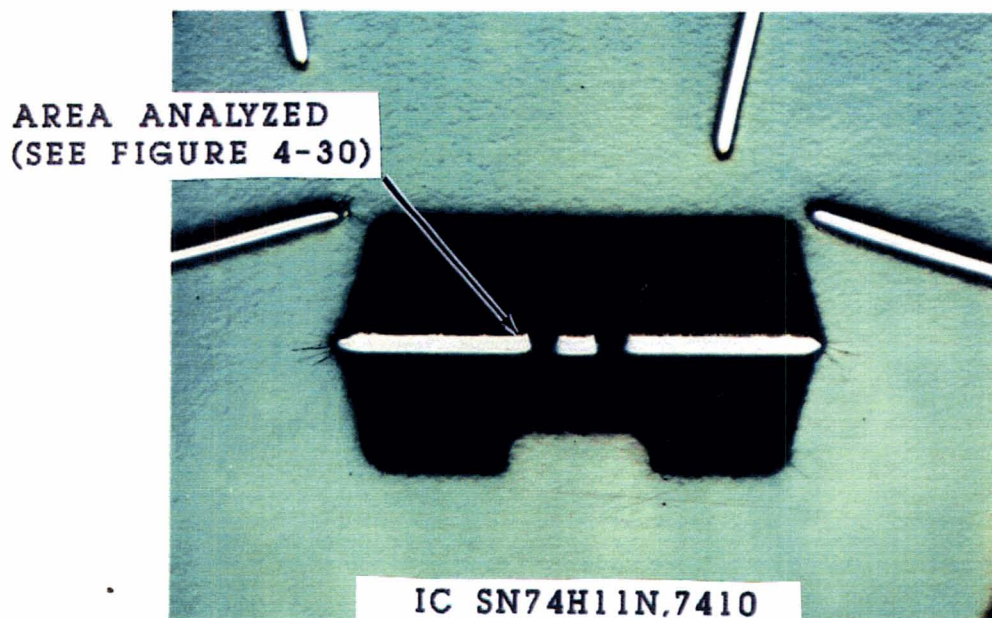
FIGURE 4-29

Four IC's were metallographically mounted and sectioned to investigate the possibility of S migration along the pins into the package (see Figure 4-29).

CROSS-SECTION OF THE FOUR IC's ARE SHOWN IN A METALLOGRAPHIC MOUNT (TOP). THE PINS WITH THE  $\text{Ag}_2\text{S}$  WERE REMOVED PRIOR TO MOUNTING TO PREVENT CONTAMINATION, AN EXAMPLE OF THE MICROPROBE ANALYSIS IS PRESENTED IN FIGURE 4-30. THE AREA ANALYZED IS IDENTIFIED ABOVE (ARROW).

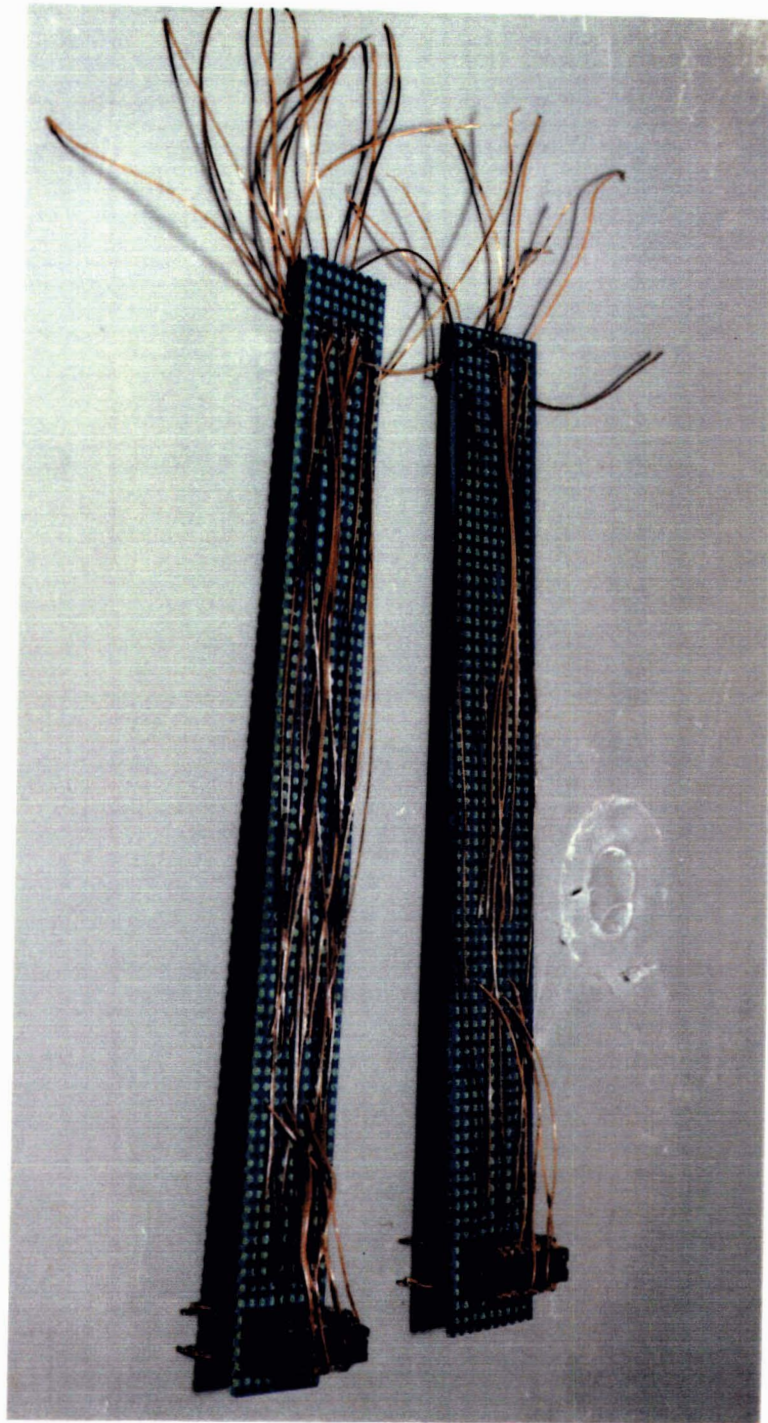
FIGURE 5-1

5.2.2 The boards were subjected to a humid  $H_2S$  environment for approximately 30 days. After the 30 days the conditions of the boards were documented. The  $H_2S$  was produced in a desiccator by adding  $H_2SO_4$  to a  $Na_2S$  solution. The environment was regenerated on a weekly basis.

THE TWO TEST BOARDS, ABT1 AND ABT2, WHICH WERE  
SUBJECTED TO 30 DAYS OF A HUMID  $H_2S$  ENVIRONMENT  
ARE SHOWN.

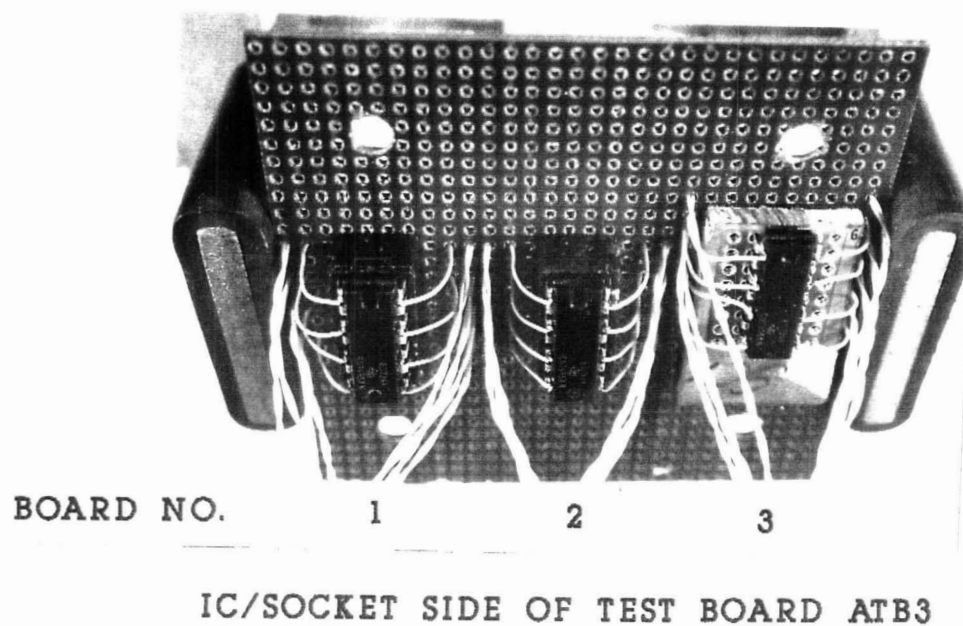
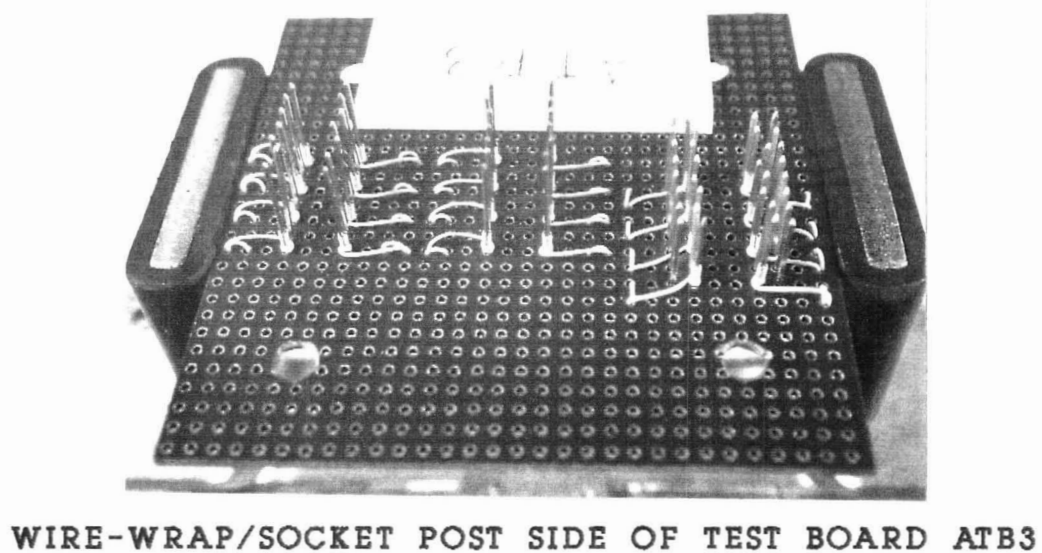
FIGURE 5-4

5.3.2 The sockets were prepared for environmental test. The three sockets were mounted on a piece of perforated circuit board with 8 of the 14 pin contacts wired for testing. IC's, P/N SN7495AN with a date code of BS7349, were installed in each socket. These used IC's were selected for the minimal Ag plating on the pins. The test board ATB3 is shown in Figure 5-4.

TEST BOARD ATB3 IS SHOWN PRIOR TO THE ENVIRONMENTAL EXPOSURE.
